## TEST REPORT

No.: QDIN2601000141PL01\_EN

Sample Name : Fingersaver Tools  
Product Specification : 295mm,375mm,850mm  
Product or Lot No. : HST3G  
Manufacturer : JINGANG INDUSTRY CO.,LIMITED.  
Material : Plastic, Nylon, Rubber

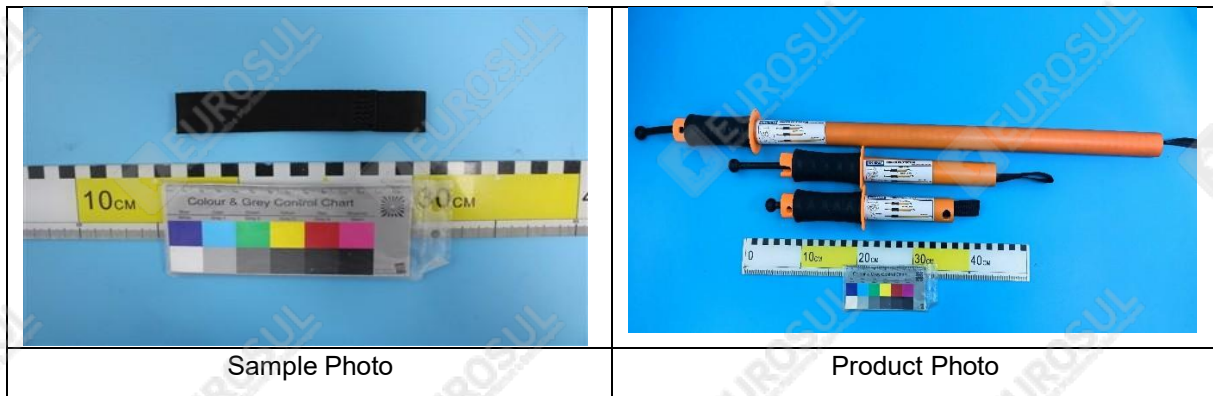
Sample Photo

Product Photo

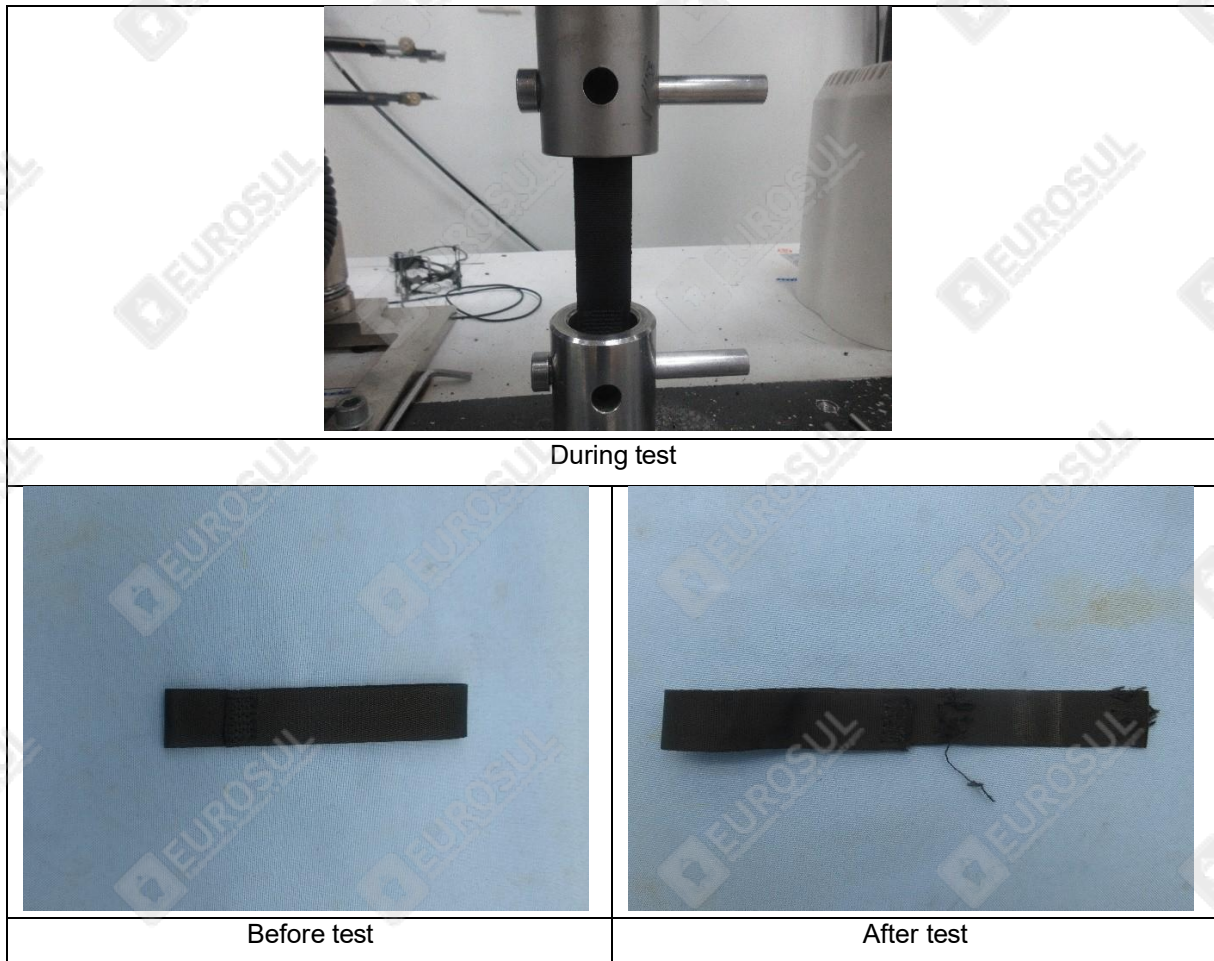
Test Photo:

Testing speed: 5mm/min

| Test Item | Test Result | Client's requirement | Conclusion |
|---|---|---|---|
| Pull Test | When the force reached 6314N, the sample was damaged. | ≥6000N | Pass |
